Tinney @ Kismet, Loftplan - State of affairs per 20th October 2014

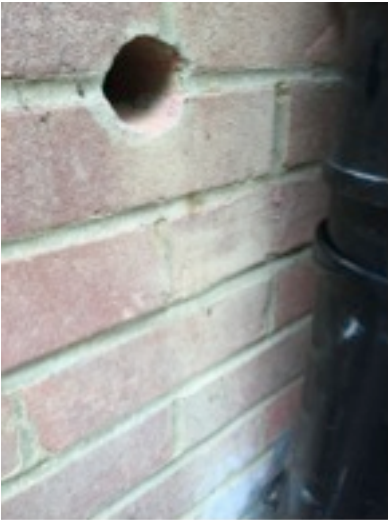
b) Outside pipes have been removed, leaving 2 big open holes

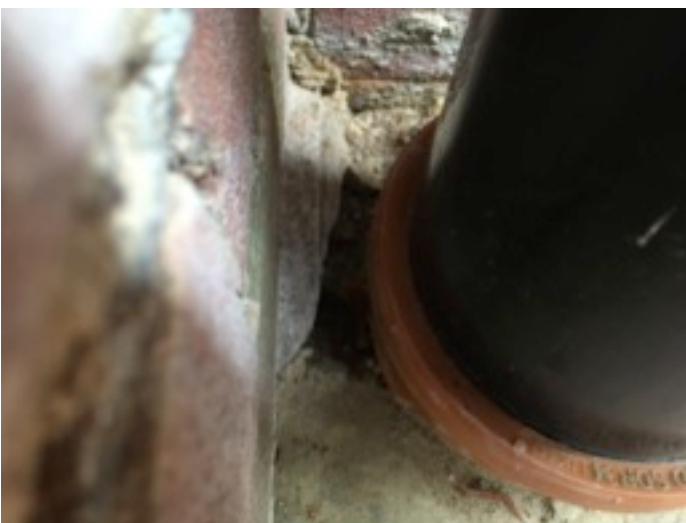
c) Area around newly fitted waste pipe has not been properly filled/ concreted.

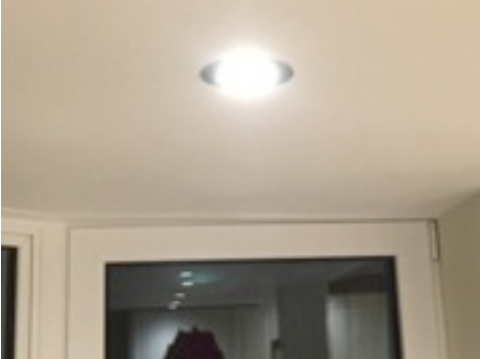
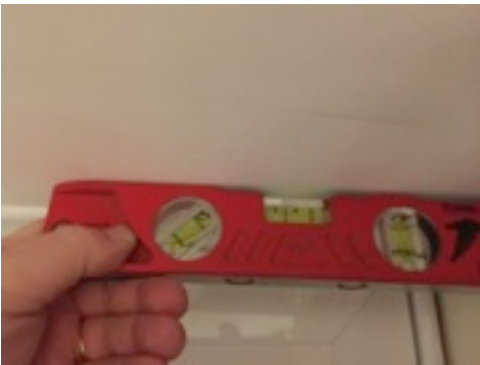
- a) Air ventilation has been totally cut off by joists and is no longer usable
- b) Extension - the suspended ceiling on the extension is not level (see pic)

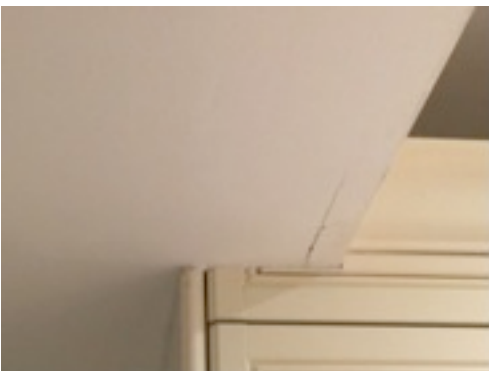
- c. The new replacement RSJ was moved over by 11cm, thus the Kitchen Cupboard has to be reconfigured/ cut into (see pic)

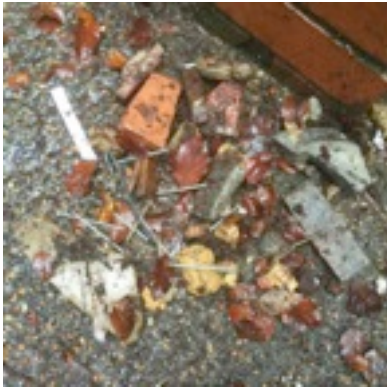
IV. Outside Gutter – Front.

Despite assurance, the guttering has clearly not been cleared.
This is what I removed last week from 1 m of guttering over the front porch (see pic)

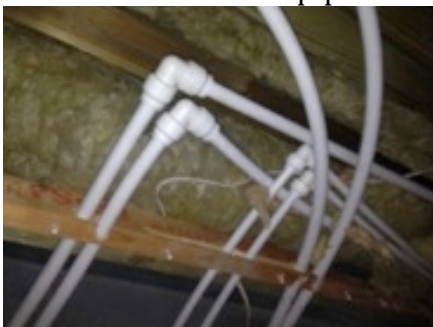
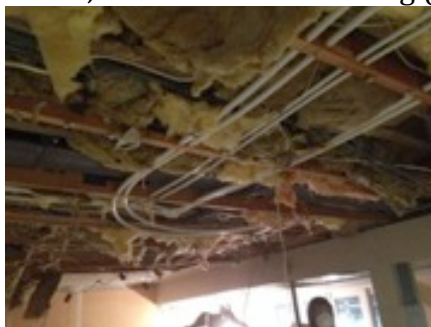
After the incident where we had to take the whole kitchen ceiling down - at our cost – to find out where & how the pipes had been laid, we found the following (more pics available)

It is our understanding that pipes are due to be drilled through the middle of the joist, not the bottom so that the pipes are not lying directly on the ceiling. We would like to get the plumbing verified by an impartial surveyor.
